SERVICE ADVISORY

NO.: 1507 Rev B

SUBJECT: Published Hold Can Be Shown On the Wrong Side

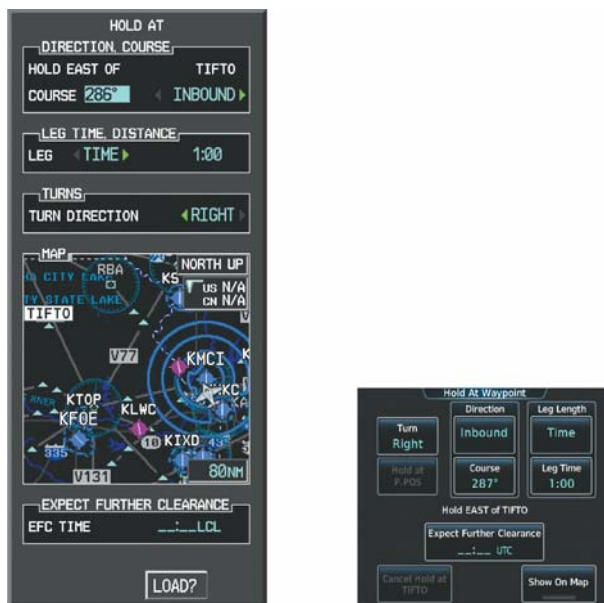
Figure 1 Example Hold At Waypoint Pages

The “hold at waypoint” direction on an approach may be shown on the wrong side if the EFC (Expect Further Clearance) Time is added on the Hold At Waypoint page (see Figure 1).

Do not use the Hold At Waypoint page to add the EFC Time to a hold that is part of an approach. Confirm all hold turn guidance against a published chart. If the hold turn guidance is incorrect, remove and add the approach procedure again.
